**Rapid Ecosystem & Coastscape Evolution
of South Florida**

**Dr. Harold R. Wanless
Department of Geological Sciences
University of Miami**

in response to
Sea Level Rise, Hurricane Events, and
Human Stresses

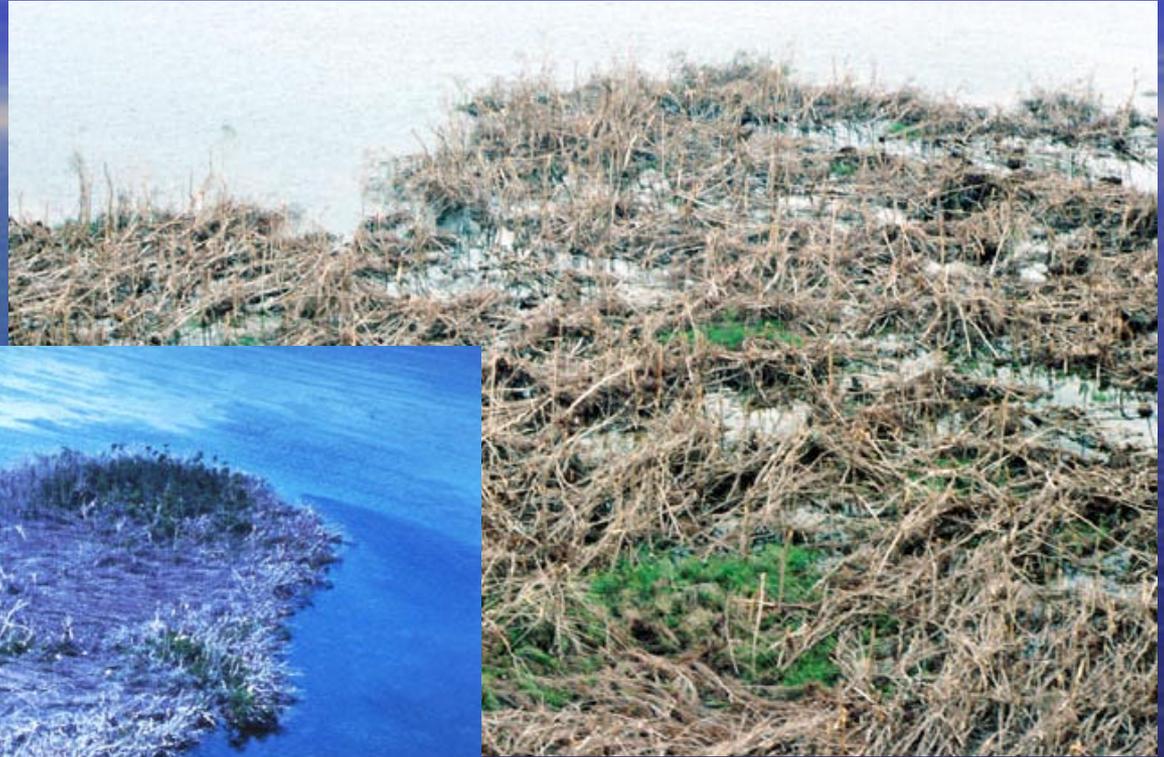
Arsenicker Keys,
Hurricane Andrew

Vast areas of mangrove swamp destroyed by the major hurricanes of 1935, 1960 and 1992 have evolved into shallow bays because –

- the rapid subsidence of the root peat prevents recovery as a mangrove community.

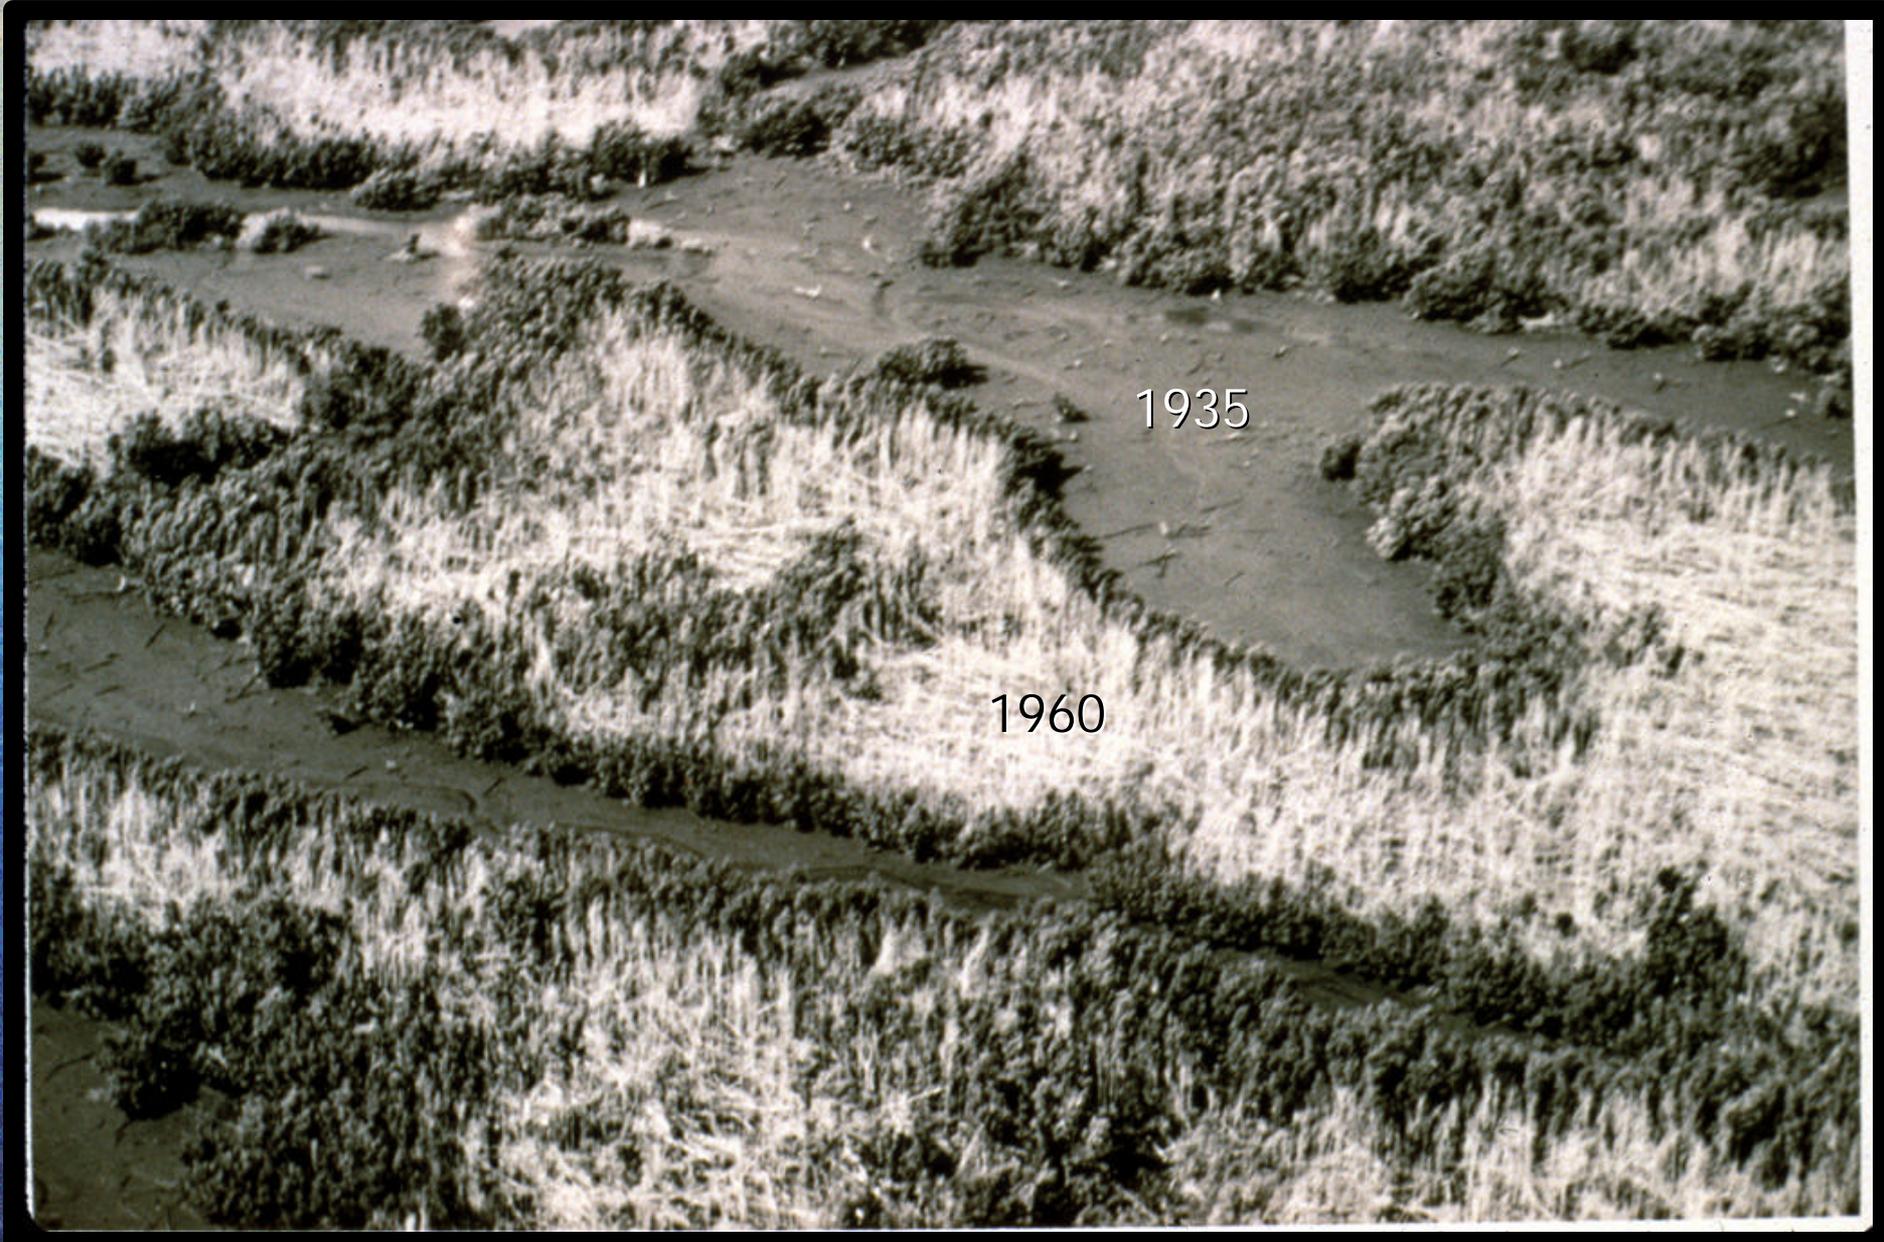
The Great Labor Day Hurricane of 1935 decimated the mature mangrove forest of Big Sable Creek.

Figure 3-5. Sequential aerial photographs showing the impact of the Great Labor Day Hurricane of 1935 on Big Sable Creek and minimal recovery in the subsequent 18 years. The area was mature black mangrove forest with narrow tidal creeks prior to the storm. See Figures 3-6 to 3-10 for sequential maps.

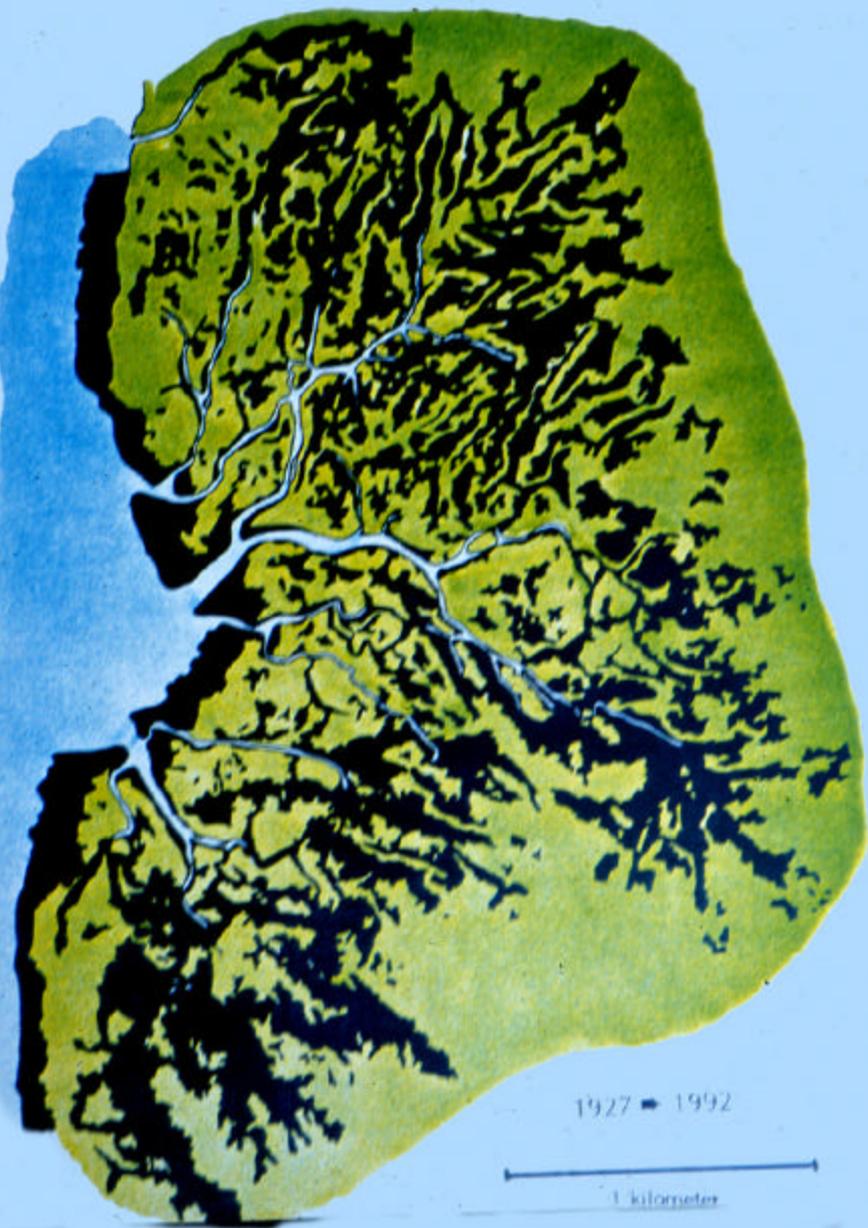
Higby Creek (A45)

1927 - 1992

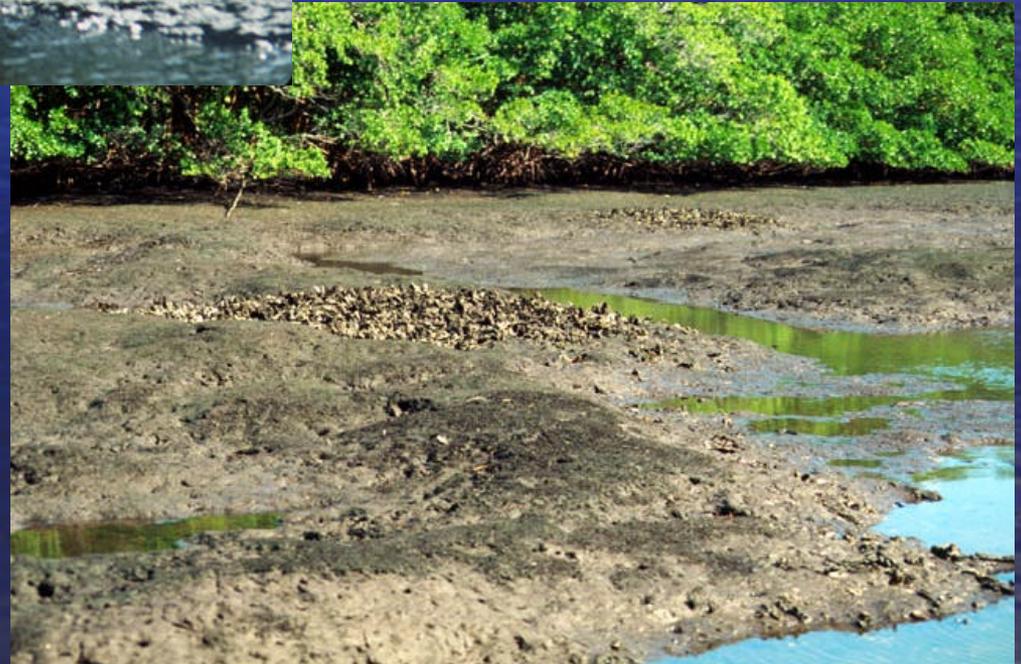
Dead peat surface is now about 3' (1 m) lower than living mangrove surface.

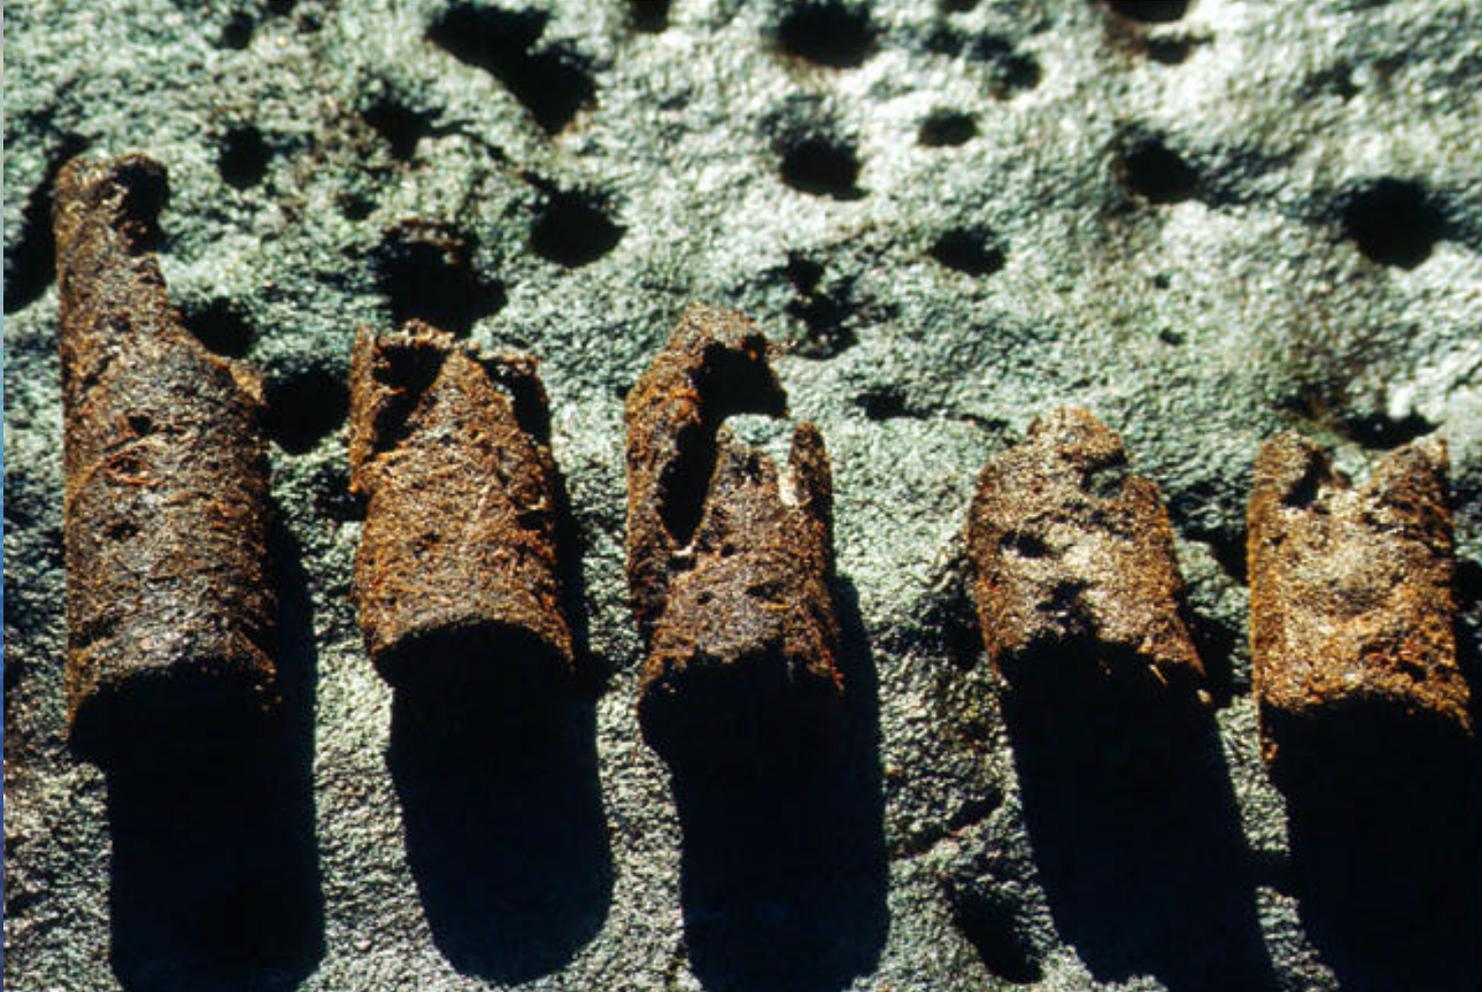
Oysters on subsiding peat

Now in the lower intertidal, excavating burrowers are accelerating the deepening process.

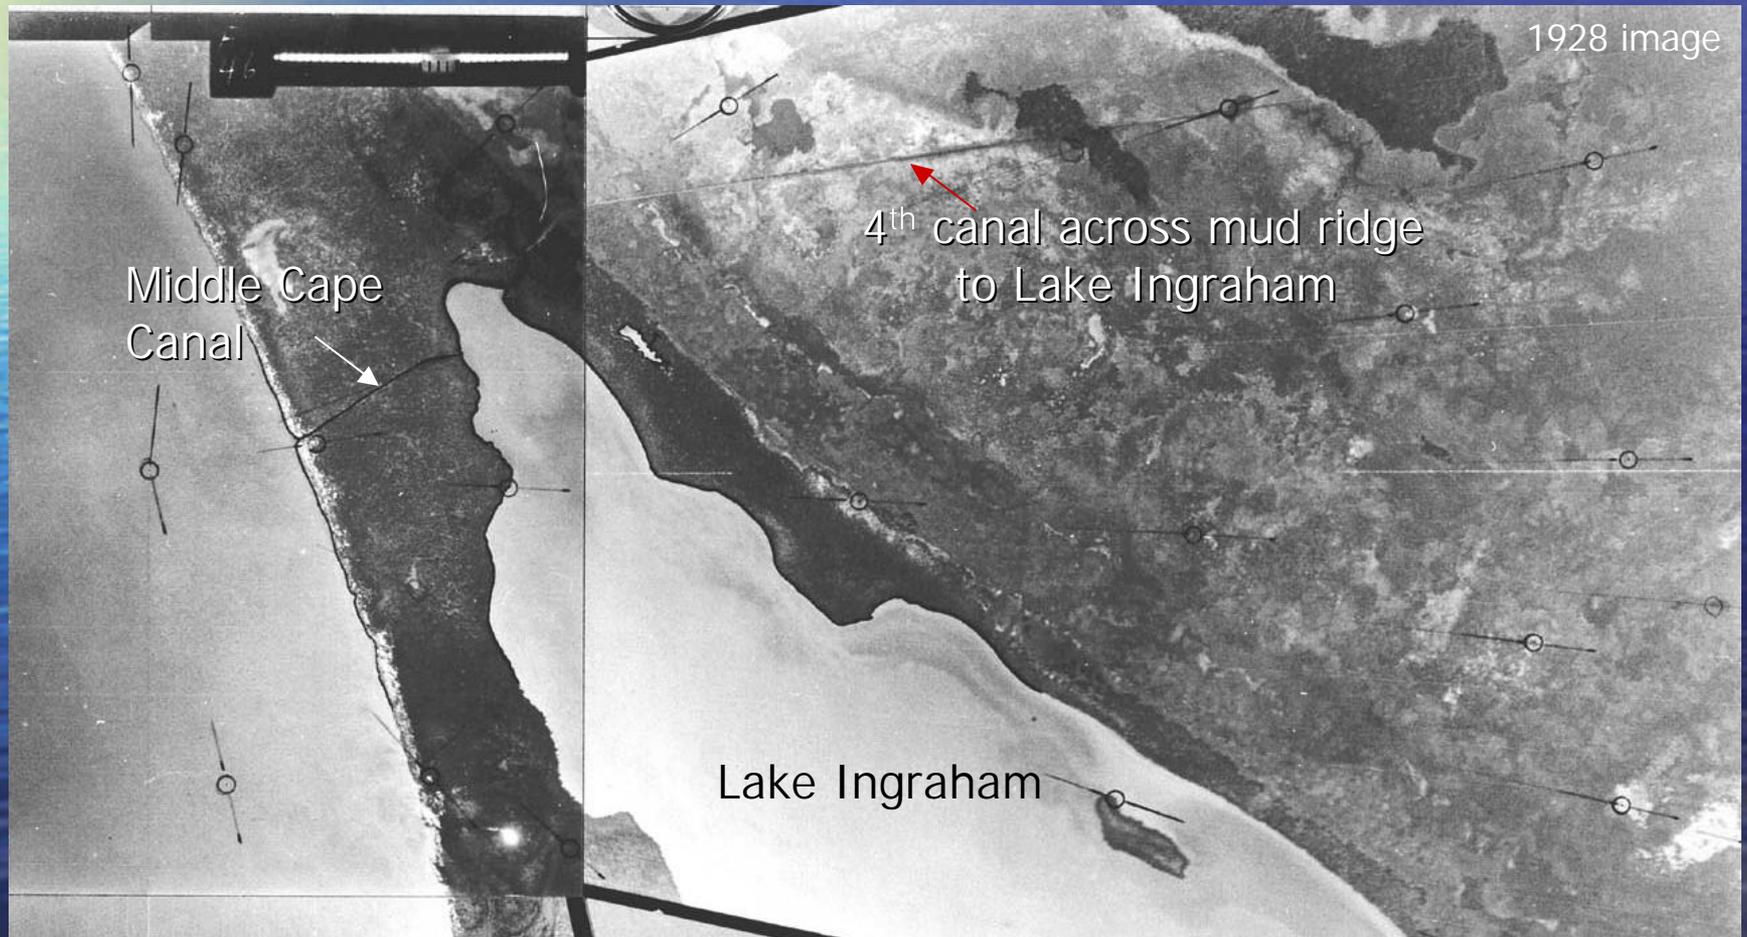
Two aerial views of Middle Cape Canal in 1928

Middle Cape Canal at the north end of Lake Ingraham was dredged only 18 feet wide.

Connection to north end of Lake Ingraham:

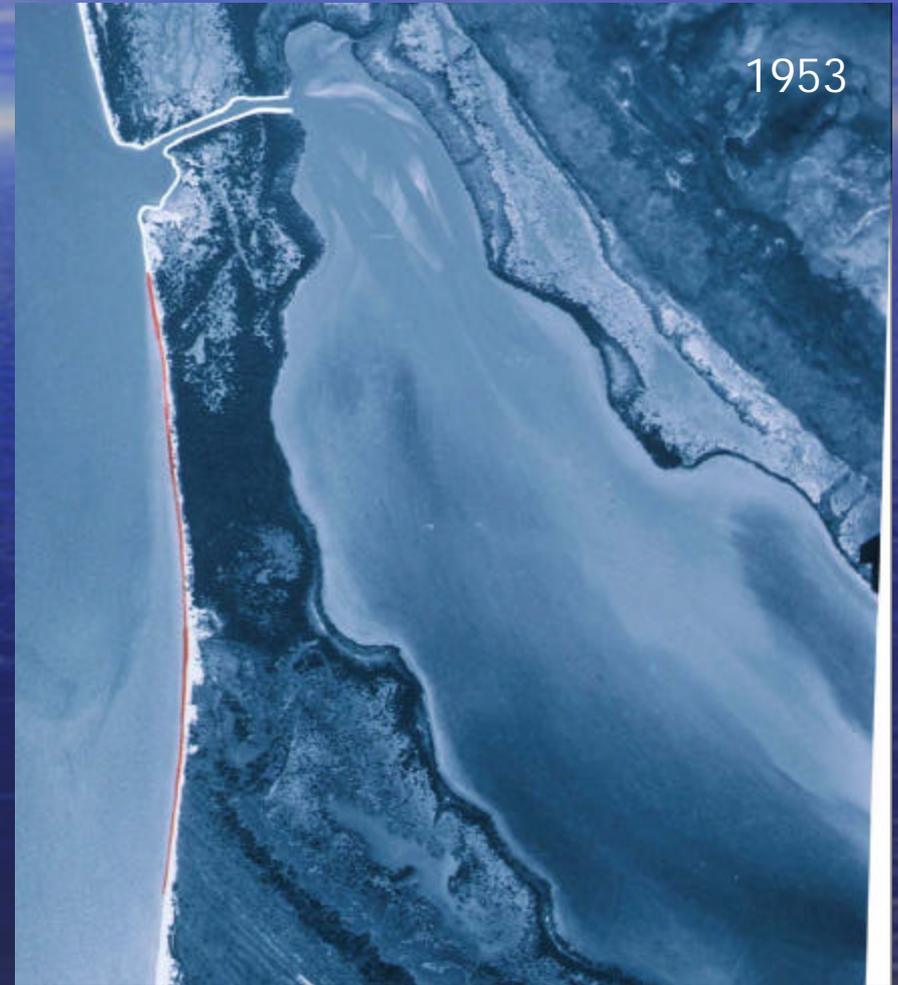
1953 – Hurricane of 1935 destroyed coastal wetland, eroded shore, and swept sand from Canal mouth initiating progressive enlargement by currents from tidal flow and winter storms.

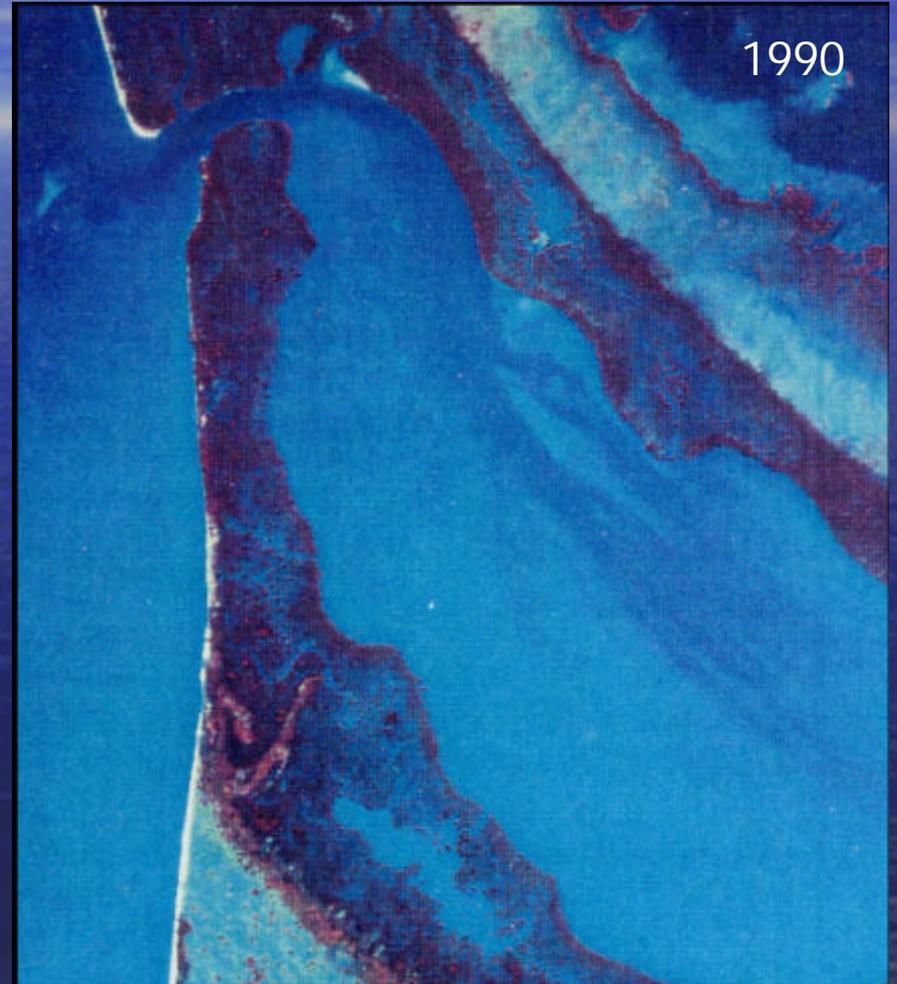
1990 – Continued shore erosion and widening of Middle Cape Canal. Well-formed channel appears off north side of inlet.

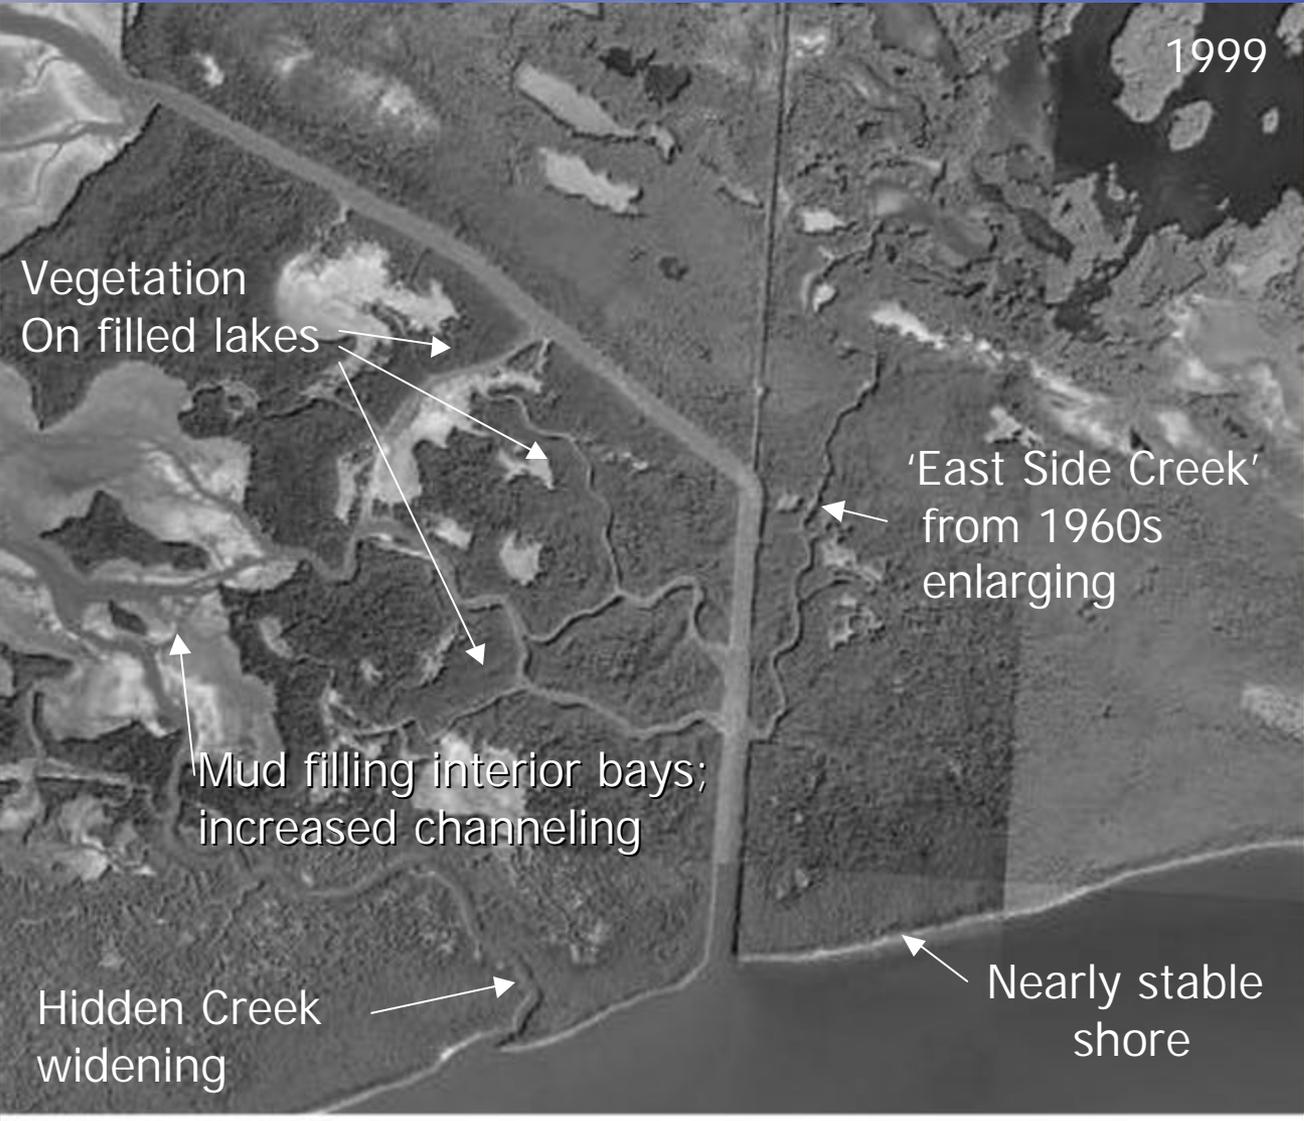
East Cape Canal has a similar history, except that there was never significant beach sand at the shore. As a result, the channel began widening immediately following construction.

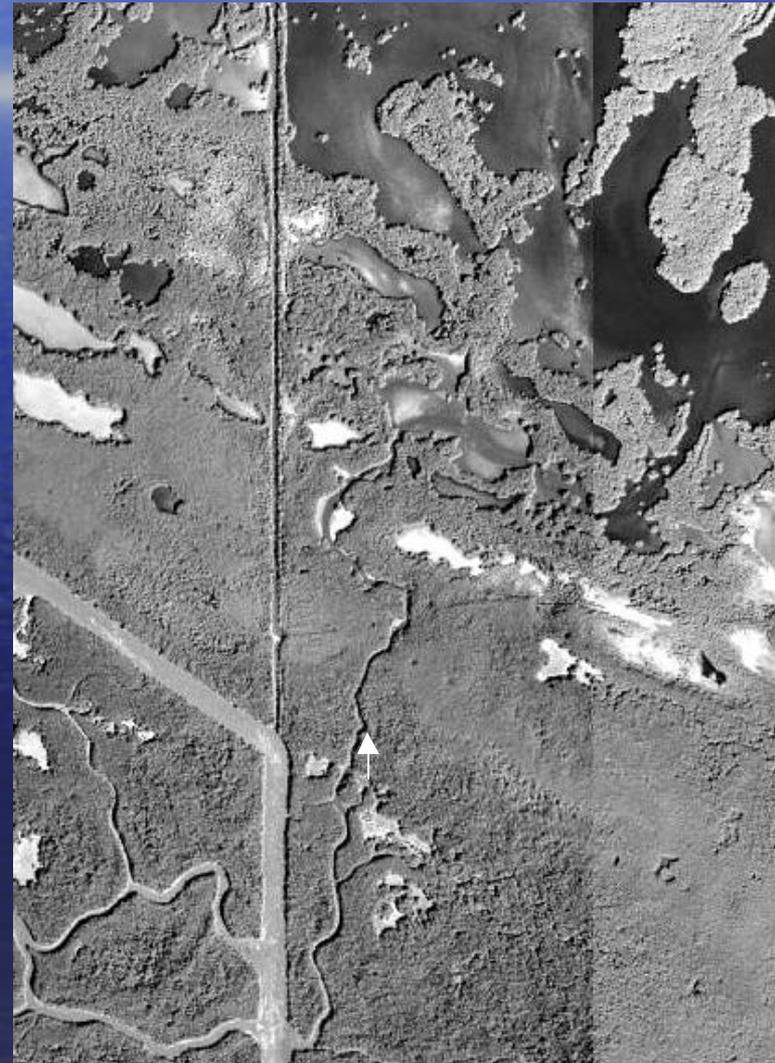
1. 'East Side Channel' has cut through the marl ridge just east of East Cape Canal.

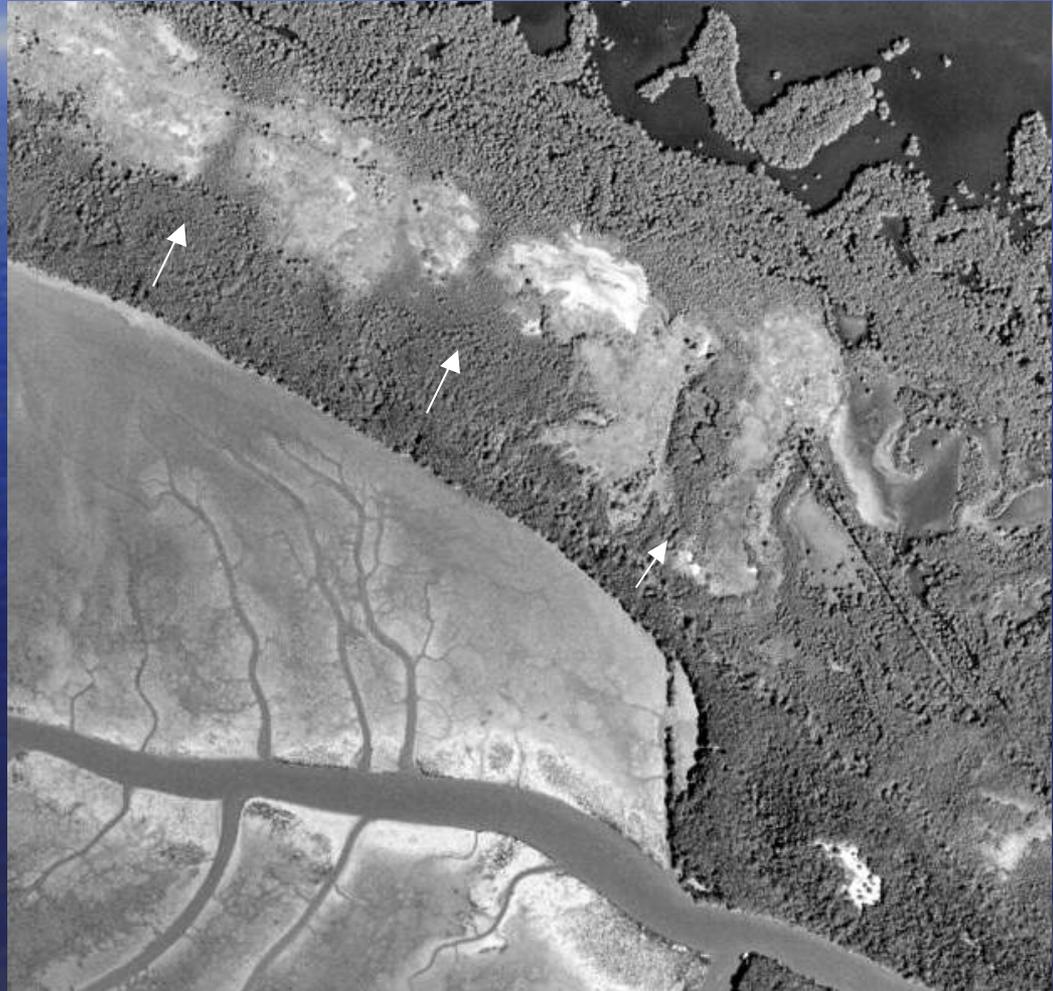
2. 'Several depressions (dark) in the ridge occur in the southeast corner of Lake Ingraham.

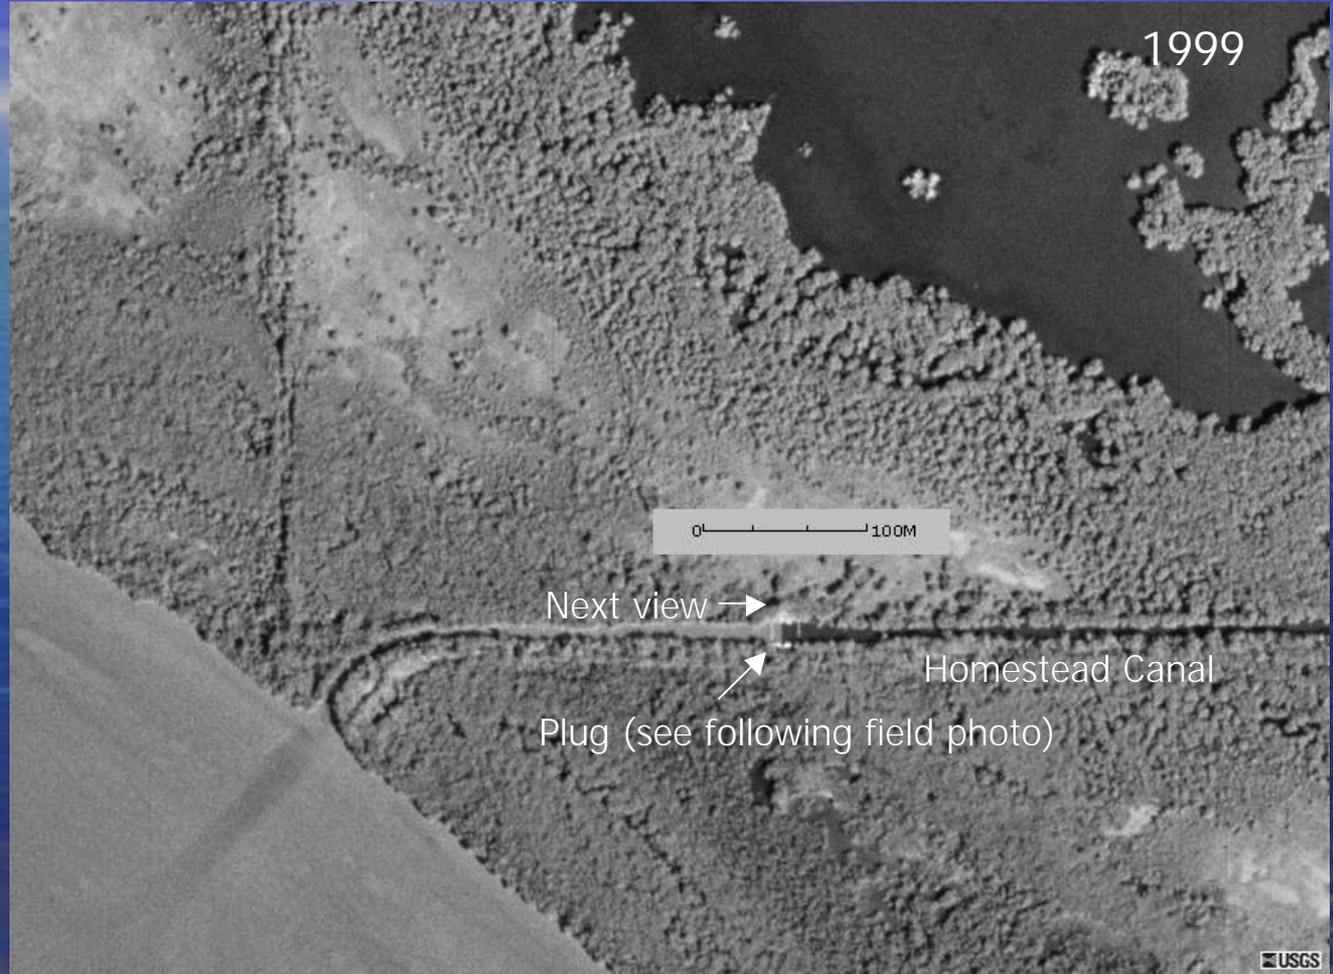
Structures have been created to limit saline intrusion.

Homestead Canal was enlarging until a plug was put in. This Canals is through a low area in the marl ridge, making containment of high water levels difficult.

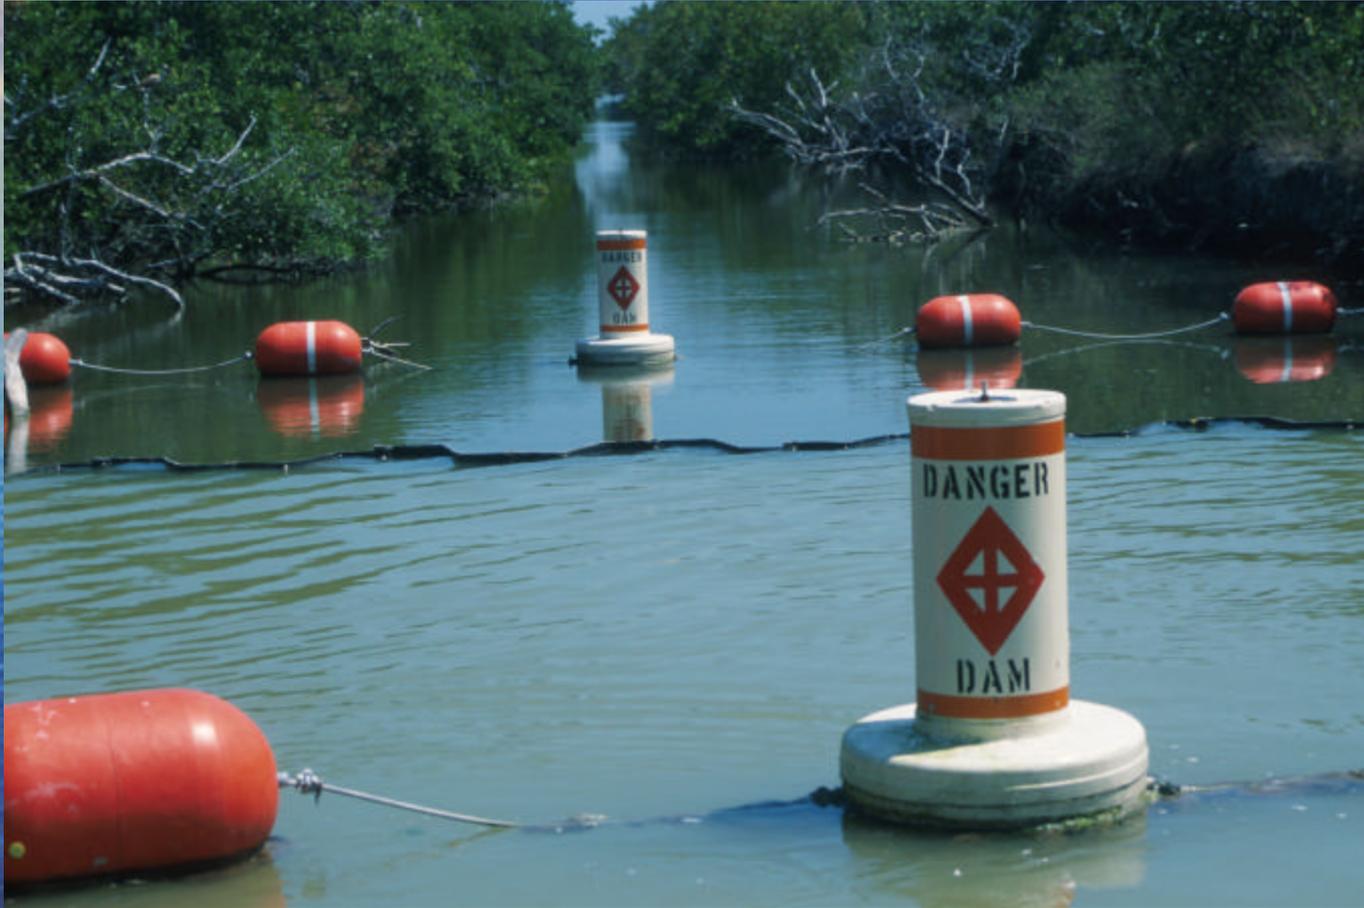
Existing structures designed to block flow in canals through marl ridge are being overwhelmed by rising sea level.

Tide from Lake Ingraham overtopping dam structure at end of Homestead Canal.

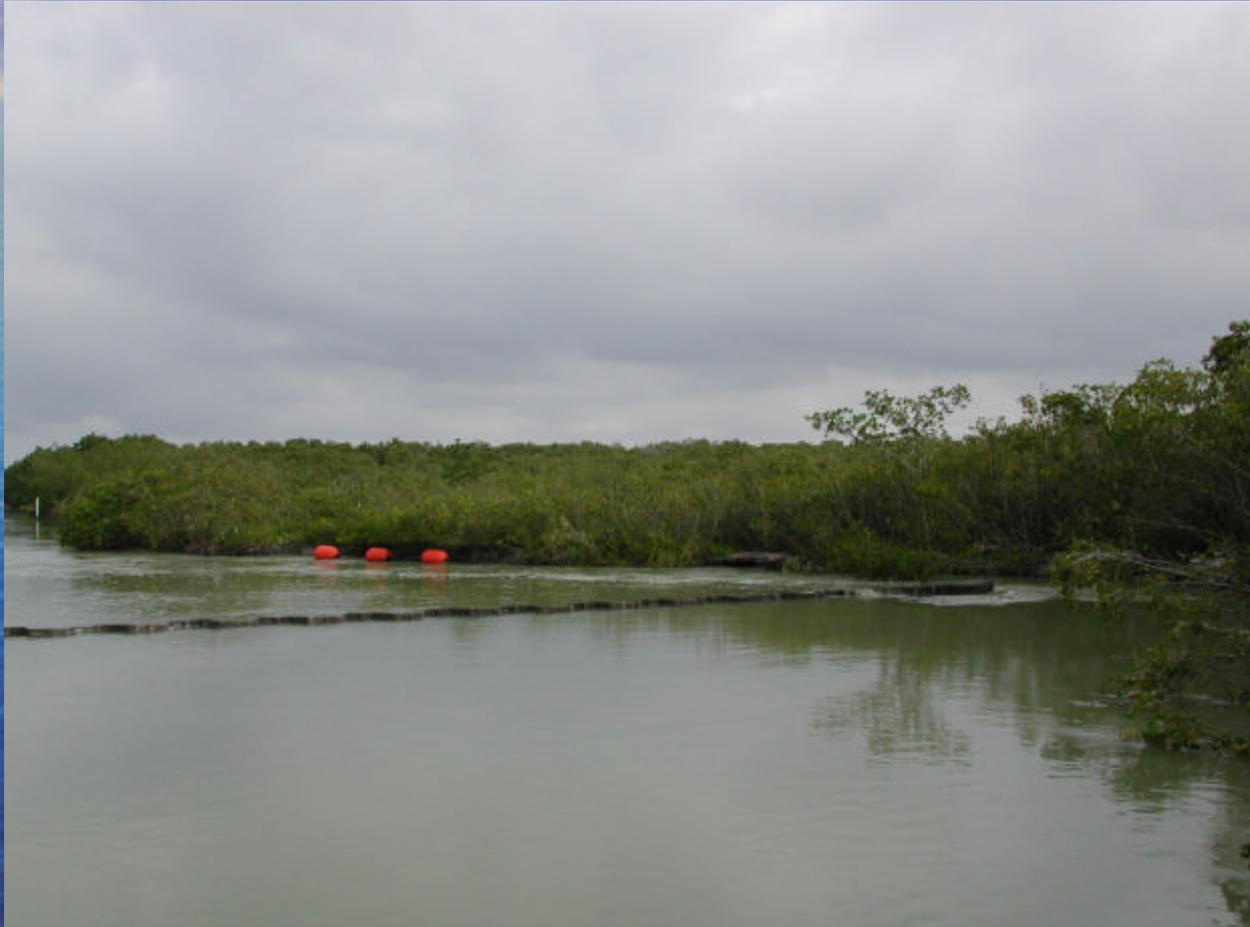
Existing structures designed to block flow in canals through marl ridge are being overwhelmed by rising sea level.

Tide coming in East Cape Canal is eroding marl around edge of dam along northern extension, February, 2002.

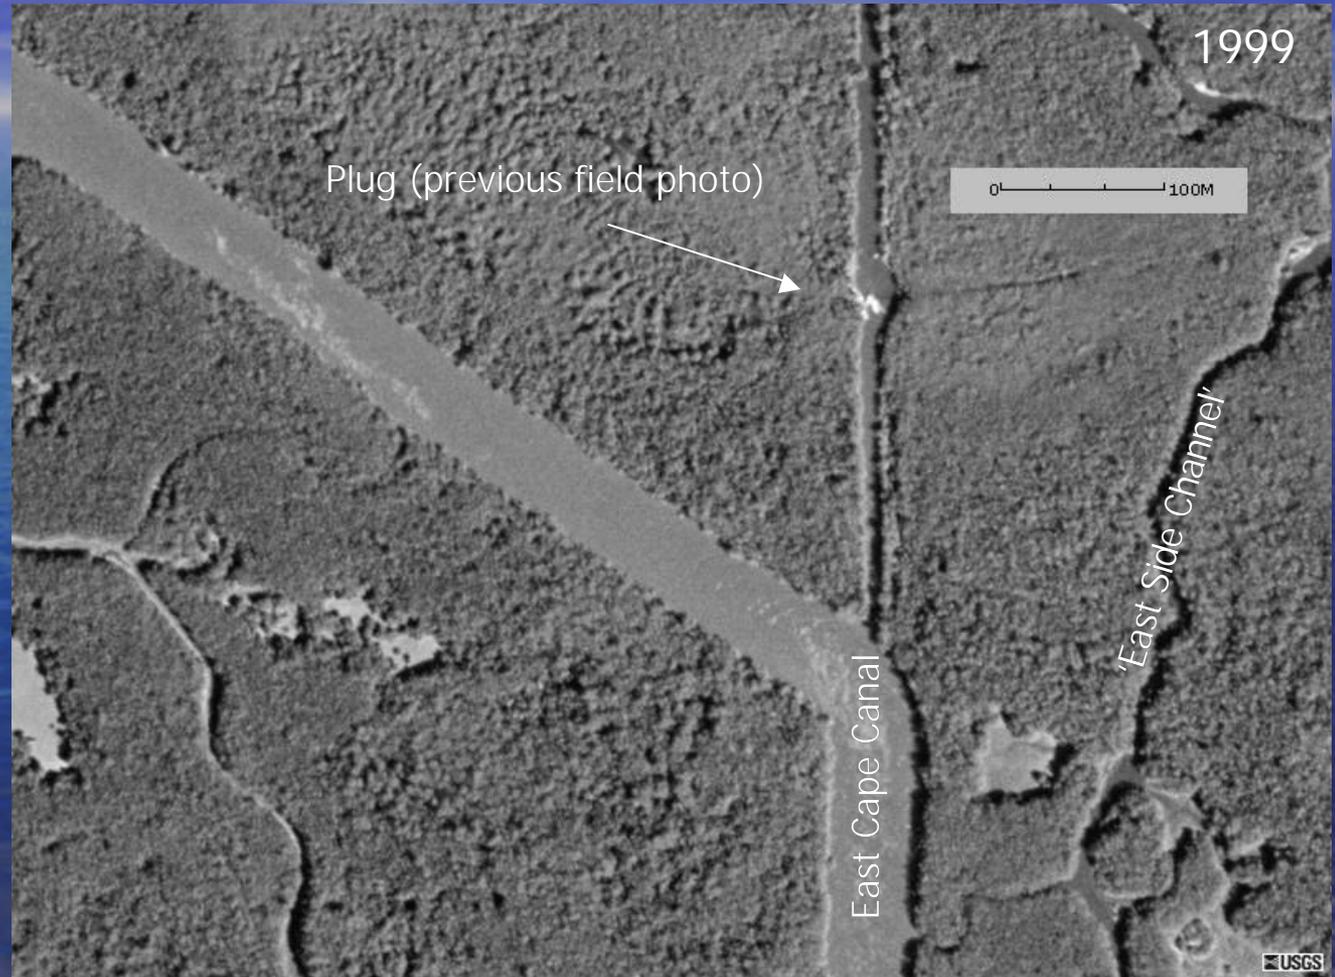
1999

Structures cannot block advancing seas as rising sea level inundates adjacent land.

East Cape Canal has widened somewhat. The plug, in a low area in the marl ridge, cannot block high water levels. A channel has cut around the right side of the structure.
