Be A Shipwreck Detective!

In September 2003, NOAA’s Ocean Exploration Program visited a newly discovered shipwreck in the Stellwagen Bank National Marine Sanctuary on the coast of Massachusetts. Underwater archaeologists studied the wreck to learn more about what happened to cause the ship to sink. Now it’s your turn to be a Wreck Detective!

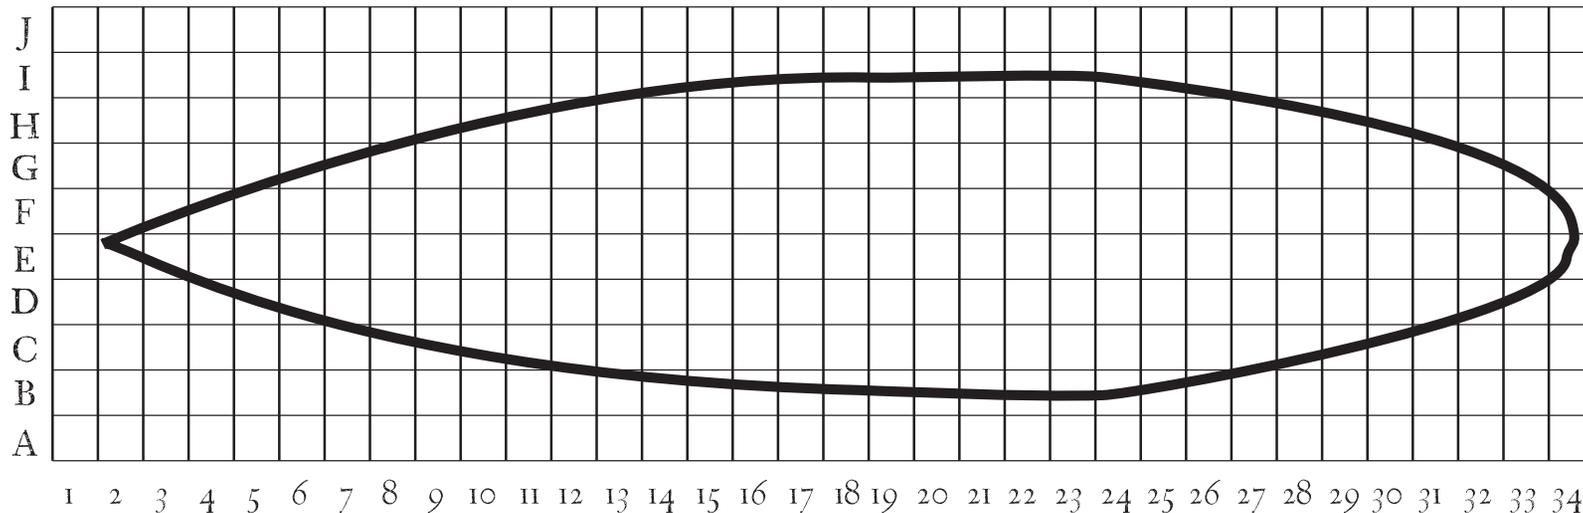
Grid Reference System for Unidentified Shipwreck Q11WRK5

1. Your first task is to organize information about where the artifacts were found on the shipwreck. The “List of Artifacts” gives a grid location for each item and how deeply artifacts were buried (so “22 inches from surface” means the object was buried 22 inches into the sea bottom). Archaeologists often use a grid system to precisely record the exact location of artifacts and their relationship to each other. You have already

NOTE: Extensive debris around main wreck, mostly large timbers and pieces of heavy equipment; several lifeboat remnants outside main wreck. Less obvious structural debris in quadrats numbered 25 and higher; these quadrats contain mostly silt down to the apparent hull of the vessel at approximately 140 inches.

The large paddlewheels near the middle of the ship clearly suggest a sidewheel paddleboat. This was a large vessel for a paddlewheel; over 280 feet. The diamond shaped metal structure is probably the remains of a walking beam engine, a common design in ships of this type. The fact that this was a large paddlewheel narrows its probable vintage to between 1890 and 1910. Artifacts in quadrats D10, D13, and G10 suggest that men, women, and children may have been aboard, and these areas may have been staterooms. The fact that artifacts in these areas were close to the surface suggests that these staterooms were on or near the deck of the vessel. Eating utensils recovered from more than 80 inches below the surface suggest a dining area, located on a lower deck. Engraved silver flatware and the carved wooden plank are valuable clues, suggesting that the name of the vessel may have begun with the letter "P" and ended with the letters "rtland." Many of the artifacts suggest wealth and luxury. This vessel almost certainly carried some wealthy passengers.

Think about the size of the debris field. Ships that sink suddenly (such as those sunk in battle) often have a rather small debris field. Ships that sink with lots of movement, on the other hand (such as ships sunk in storms) are likely to have larger debris fields. This ship has an extensive debris field, suggesting that a lot of motion, possibly due to a storm, was involved in her sinking.
